THE CHANGES IN PRECIPITATION DURING 124 YEARS AND ITS INFLUENCES ON THE PHYSICAL CONDITIONS OF HERNÁD RIVER

Keywords: *precipitation, water level, meandering, River Hernád*

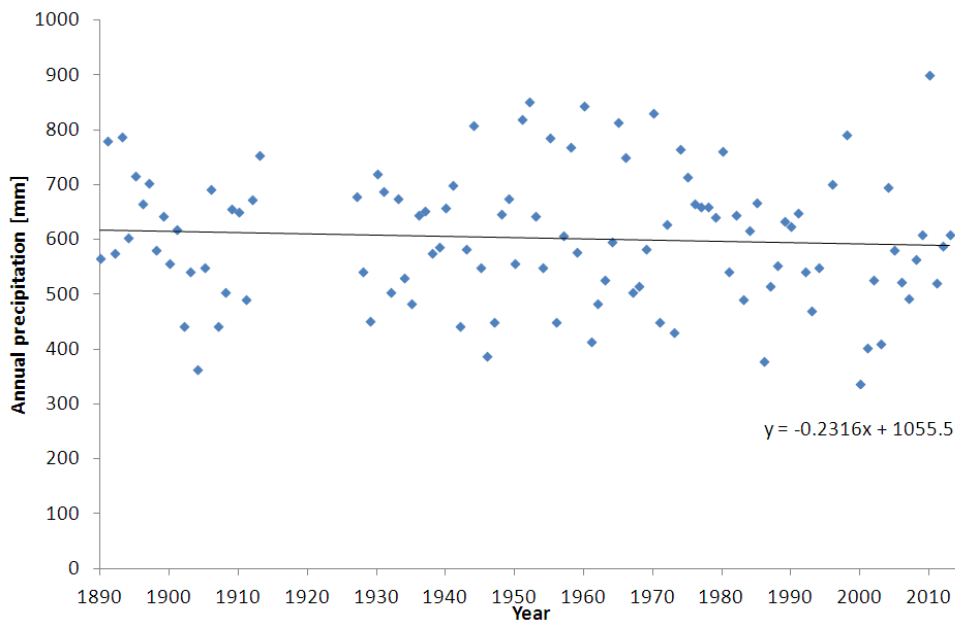
Figure 3. Amounts of annual precipitation between 1890 and 2013 in Hidasnémeti

Based on the evaluation of precipitation data over more than a hundred years it is evident that total amount shows a declining tendency. The quantity of precipitation has been reduced by 0.23 mm a year (*Fig. 3*). These results are in accordance with the hypothesis that a slow dry-up period has begun in the Carpathian Basin (IPCC 2011; Bartholy & Pongrácz, 2008; Horváth, 2009). Szász (1994) had some similar conclusions in his work. He expressed a definite descending tendency while he was analysing it in Hungary by assembling and comparing precipitation data of major meteorological sampling sites.

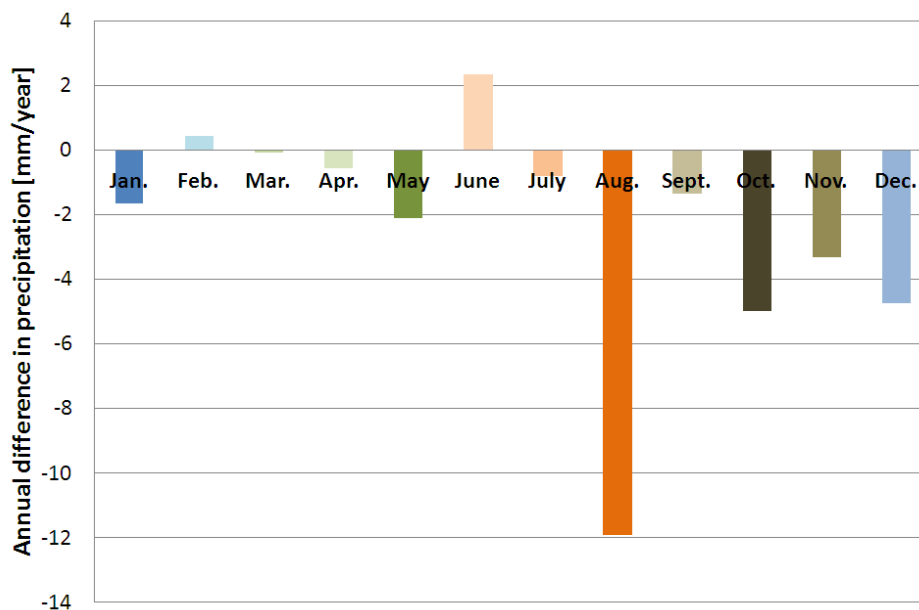
Figure 4. Total change of the amount of precipitation on monthly basis, between 1890 and 2013 in Hidasnémeti

On the analogy of annual precipitation amounts monthly precipitation from 1890 to 2013 were calculated and tendencies were verified (Fig. 4). As the graphically described monthly sectioning represents there is a certain decrease in precipitation volume besides of two separate months, February and June. Aridity in August and winter months catches everyone's eye. Thus, in accordance with former graph a reduction in precipitation amounts is clearly observable.

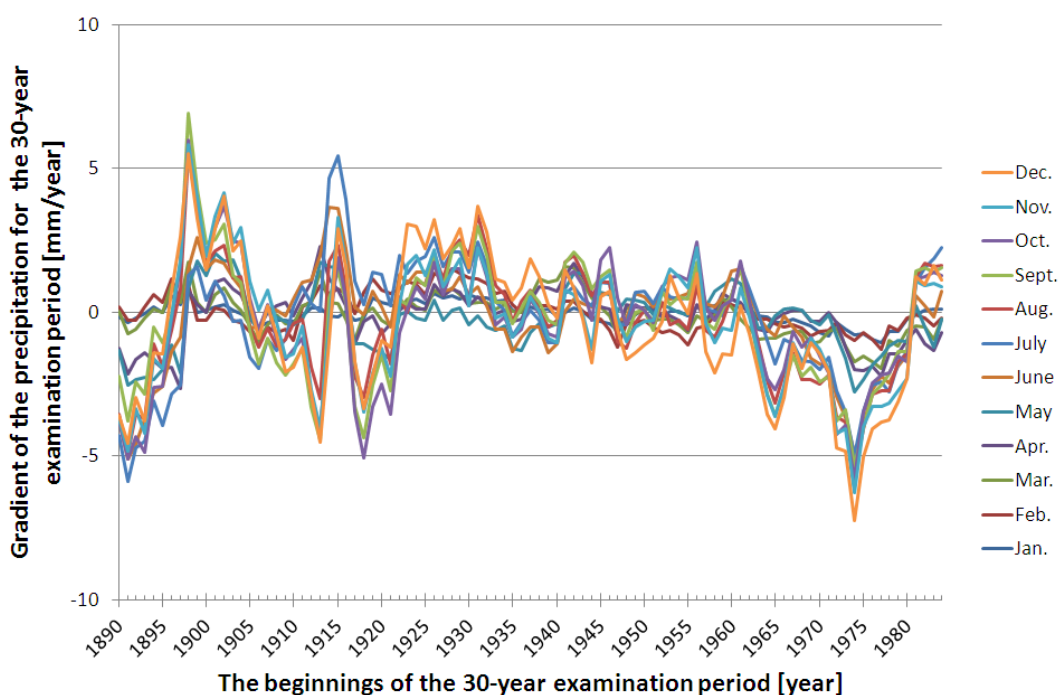
Figure 5. Tendencies of changes of precipitation on monthly basis

To study this tendency, this research was extended with one more aspect. The investigations related to reduction in precipitation amounts and tendency-analysing were carried out by adopting the WMO sectioning where each period includes 30 years. The gradients of the precipitation for the 30-year examination period were calculated, which were the degree of the variation in precipitation [mm/yr]. The gradient values were plotted against the beginnings of the examination period, separately for the months (Fig. 5). First period concerns a time frame 1890-1919, the next one 1921-1950, etc. Each study period appear in one-year offset. The last examined 30 years includes the years from 1984 to 2013, because of this, the last points can find above 1984 on the diagram. The graph below (Fig. 5) compares the figures for quantity changes in precipitation-periods of 30 years and the precipitation changes self. Regarding the investigated time period of a hundred and twenty-four years the reducing tendency in precipitation is obvious it does not matter from what directions graph data are analysed. Decrease began early 1930s touched the bottom in the middle of 1970s approximately, and after a certain stagnation period it started growing towards zero. The local intensity was remarkable however the for last few years characteristic tendencies in terms of extreme weather conditions could not be recognised in this tendency as significantly.

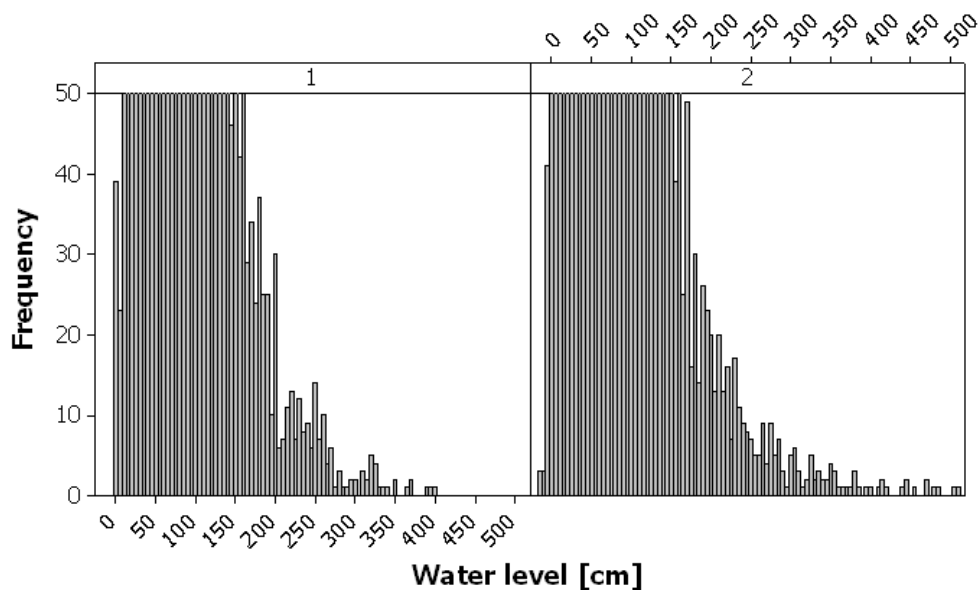
1: 1946-1975; 2: 1976-2011

Figure 7. Changes of maximum values of the water level on the Hernád (enlarged part of the circled part of Figure 6)

space for new unique domains while processing data. This option performed as a single classification itself. Thenceforward, it was authors' duty to verify results. Taking a daily basis into consideration, the following water level-classifications were created: (-5)-5 cm, 5-10 cm, 10-15 cm, etc. Results clearly show that water regime in first period (1946-75) is more balanced compared to the second period (1976-2011) when it moves towards more extreme values. Therefore, values of low water have remarkably grown just as the frequency of water-levels above 350 cm. While comparing the results to locally experienced-climate variations, in terms of water-levels a significant movement has been approved towards low values (*Fig. 6*). The extremities of last fifteen years have been manifested in a growing frequency of high water (*Fig. 7*).

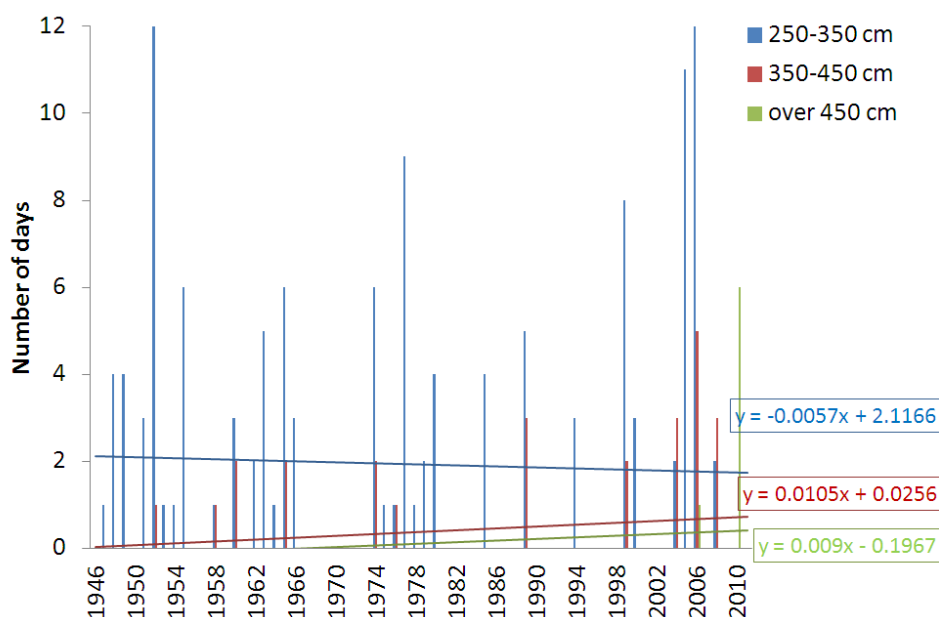
Figure 8. Changes of ordered flood gradation numbers during the last 65 years near Gesztely
I. grade of flood prevention is 250-350 cm, II. grade of flood prevention is 350-450, III. grade of flood prevention over 450 cm

Concerning the relevant river sections both frequency and grades of flood-prevention measurements were investigated in the course of data-analysis. Especially those tendencies were examined, where changes in number of measurements and their grades reflected water-level modifications. In case of River Hernád, there are three categories or grades related to flood-prevention: first grade is suitable for the case when water level is 250 cm or above, second grade is necessary for water-level of 350 cm or above, and third, the highest grade is commanded in case of 450 cm water level or above (*Fig.8*). Changes are remarkable. The frequency of first grade has been decreased. Nevertheless, commands for second and third grades have been increased significantly.

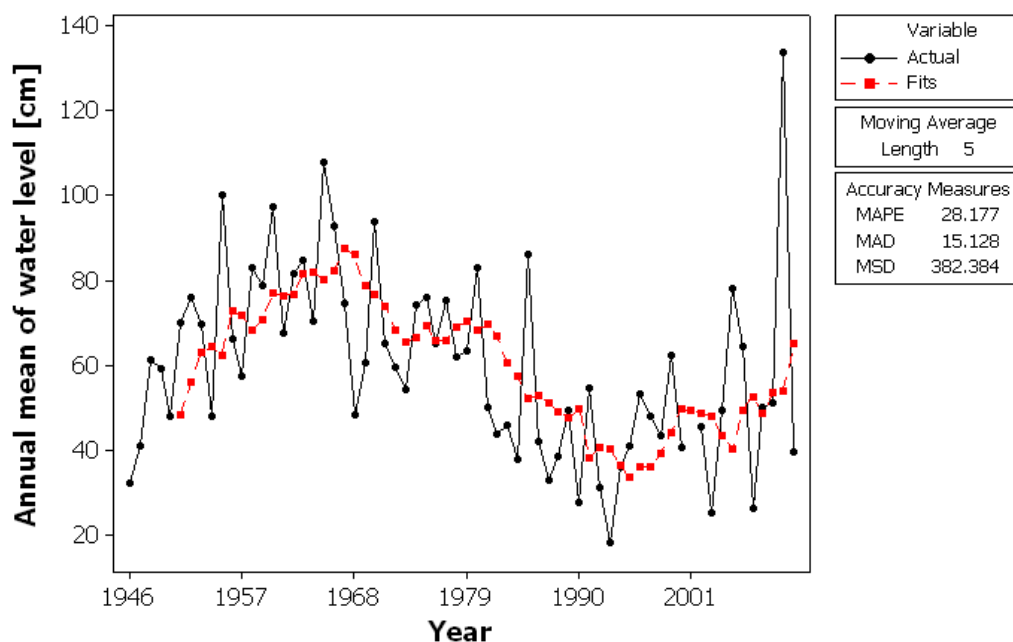
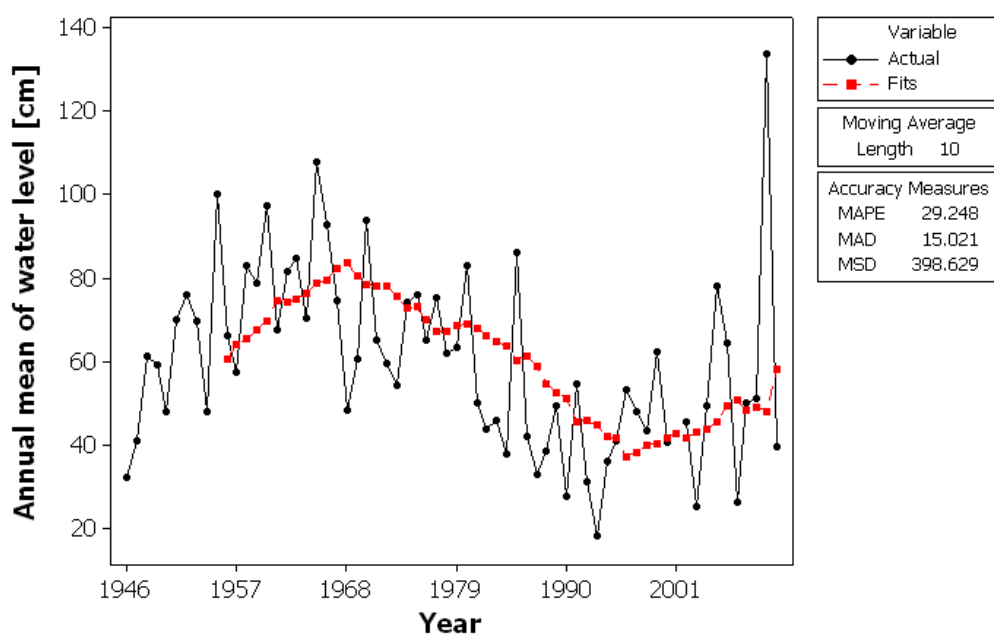
Figure 9/a.

Figure 9/b
Figure 9/a-b. Moving average of water levels of river Hernád from 1946

The decreasing tendencies in quantity of precipitation also appears in data concerning elevation of water, its moving average for 5 and 10 years indicates a strong correlation between precipitation values and water-levels (*Fig. 9a-b*). It is evidently established that the quantity of precipitation in the area has a direct or indirect impact on the elevation levels. That might powerfully influence even the shape of river-bed.

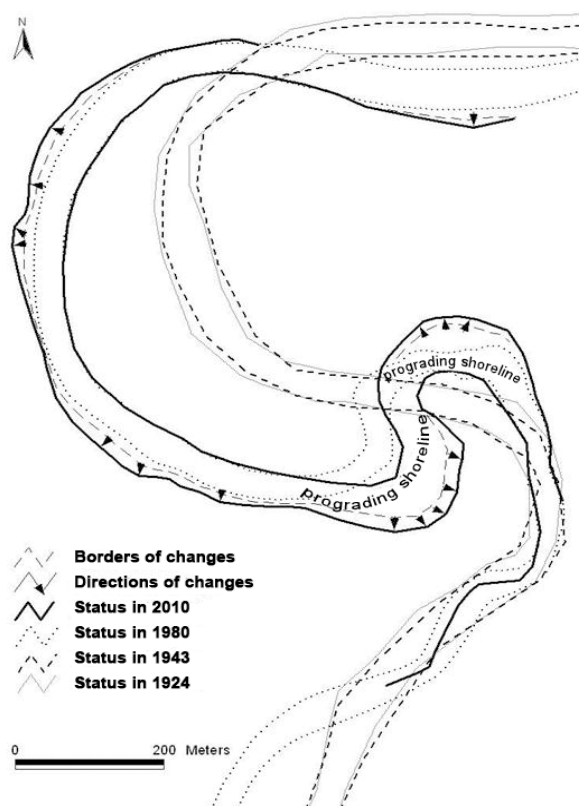
Figure 10. *Developing of the meander on the research area*

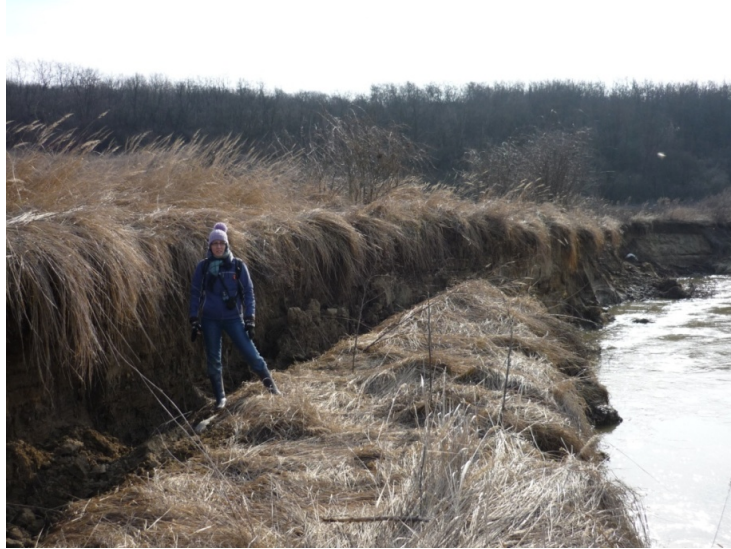
Picture 1. Block collapses along the river bank which covered by natural vegetation

The represented incidents and their effects are also strengthened by a modified land-use in the region. Last decades there was a strong transformation related to use of land in investigated areas. Territories used for pasturage or as meadowland, and orchard became stages for intensive agricultural activities. Nowadays, some parcels are reaching the riverside. Due to breaking natural vegetation, the “fastening” function of river banks perishes and it results in faster and larger devastation (*Picture 1*). On the other hand at those river sections where natural vegetation could remain and still covering river banks, a devastation process evoked by the river has had smaller dimensions (*Picture2*).

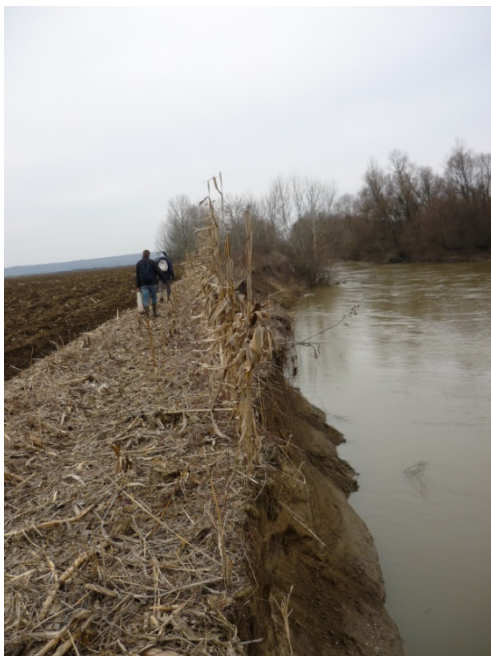
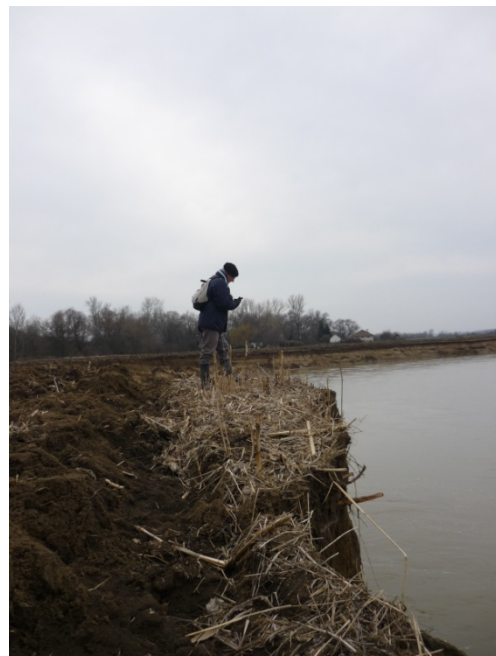
Picture 2. Strongly degrading river bank along the intensively cultivated agricultural land

According to results of recent study, modifications occurred in use of land have even accelerated it. In such areas where land-uses are different, not only the intensity of devastation has been changed, also its forms can vary. In case of lands under a more intensive cultivation along high, steep river-banks, sudden bank-collapses or inclinations are more characteristic. This means that some coherent blocks or even whole vertical walls belonging to river-banks can break off suddenly and parts of the decaying blocks can fall into the river. Whereas in river sections with bank tracks and extensive bluffs, and covered by natural vegetation, massive river banks are more likely to collapse. In general, the longer fragmentation prepares their slower decay.
