STABILITY ANALYSIS OF UNFAVOURABLE GEOLOGICAL BODIES IN A POST-EARTHQUAKE AREA: A CASE STUDY IN GENGDA TOWNSHIP CHINA

Abstract. On 12 May 2008, a devastating mega-earthquake of magnitude 8.0 struck the Wenchuan area, northwestern Sichuan Province, China. Following this earthquake event, many areas in the affected areas were susceptible to geological disasters, such as debris flows, landslides and other secondary disasters. To better understand the mechanism of the formation processes of geological disasters, and to reduce the economic loss caused by the disasters, a comprehensive analysis is required. With the aim of obtaining the characteristics of unfavourable geological bodies, and analysing their stability, we choose the Gengda Township as an example (there are many unfavourable geological bodies distributed in this area, including landslides and deformation bodies). Field investigations and computational models are employed to analyse the stability of the unfavourable geological bodies. Through preliminary analysis and model calculation, the following conclusions can be drawn: under natural conditions, the stability factor of the landslide ranges from about 1.02–1.03, which m

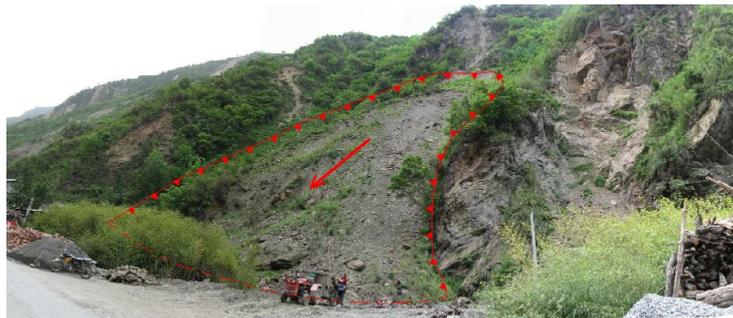
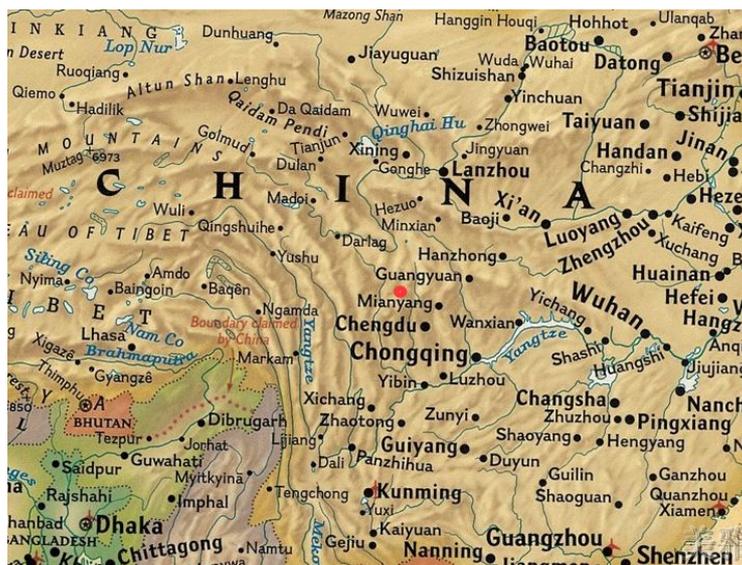
Figure 1. Full view of Nitianguo landslide (red point is the study area). **a** Landslide range, **b** location of the study area

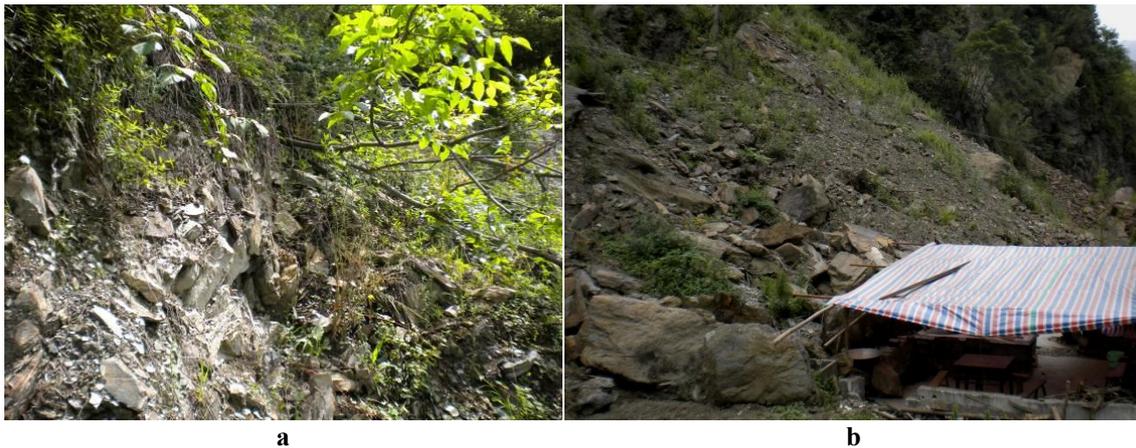
Figure 2. Other types of unstable geological bodies. **a** Collapses , **b** unstable slopes

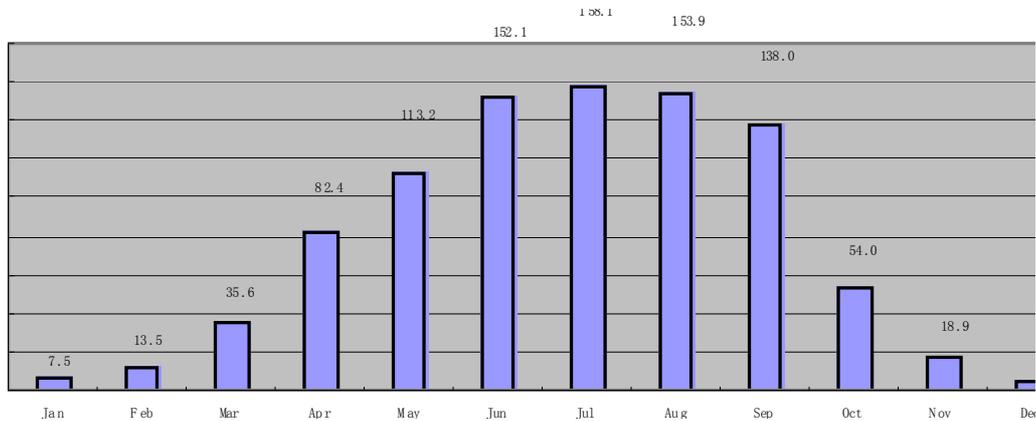
Figure 4. Histogram of historical average rainfall (mm)

Climatically, the study area falls into the subtropical humid climate zone; during winter the area is significantly affected by the Qinghai-Tibet Plateau climate, while in summer it is mainly dominated by the southwest and southeast monsoon climate. The mean annual precipitation is 930.2 mm, and the rainfall is mainly concentrated during the period from May to September, which contributes more than 78% of the total precipitation throughout the year. According to the rainfall contour diagram of Sichuan province illustrated in the manual of flood calculations for small and medium-sized basins, the rainfall data for 10 min and 1, 6, and 24 h can be acquired and the corresponding amounts are 10, 20, 65, and 120 mm, respectively. Some slopes in the study area have been loosened by the effect of seismic activity, which will result in instability under subsequent heavy rainfall conditions (Tang et al., 2011). The rainfall data from 2000 to 2009 were gathered, as shown in *Table 2*, and the historical rainfall histogram is shown in *Figure 4*.

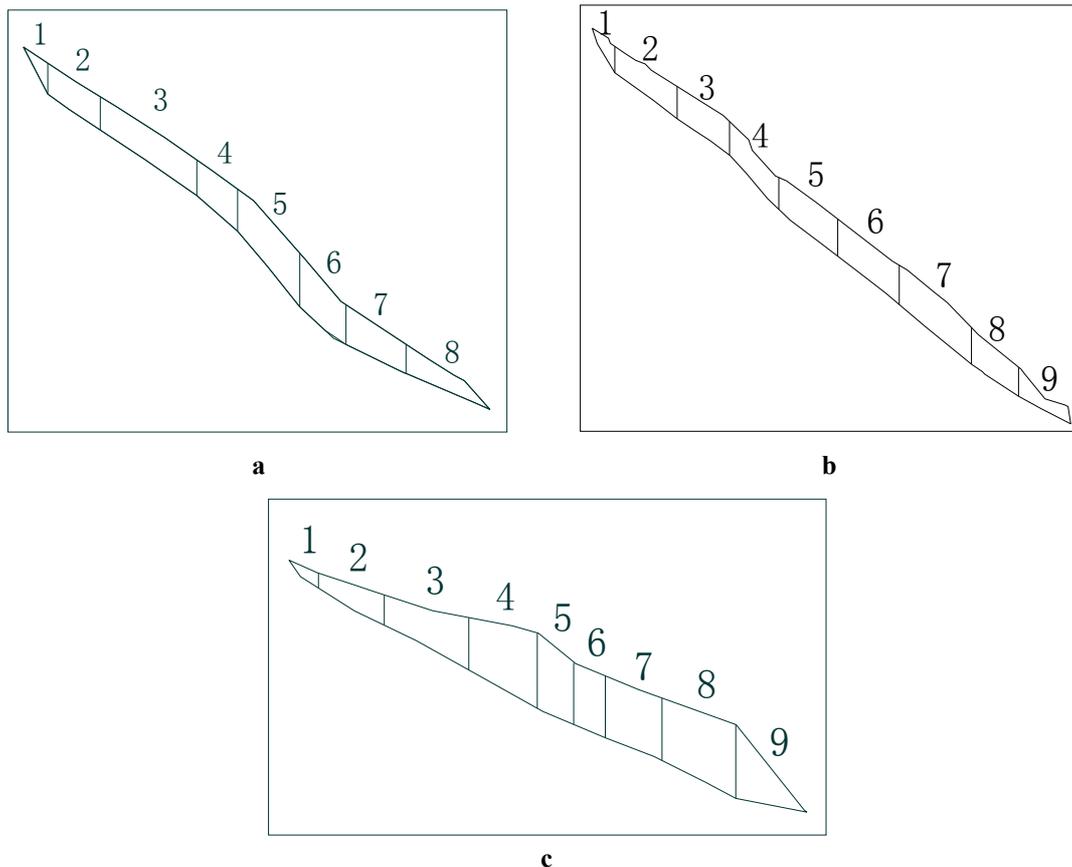
Figure 5. Stability calculation diagram of **a** strip 1 of No 1 deformation body (profile); **b** strip 2 of No 1 deformation body (profile) and **c** strip 5 of No 2 deformation body (profile)

According to the principle of the Transfer Coefficient Method, the unfavourable bodies in the study area can be vertically divided into several strips. Through preliminary analysis, we found that strips 6 and 7 are the most dangerous sliding bodies in the whole landslide, strips 1 and 2 are the most dangerous sliding bodies in No 1 deformation body, and strip 5 is the most dangerous body in No 2 deformation body. The stability calculation diagrams are shown in *Figure 5a-c*.
